Appalachian Power Company

Project No. 2210-198

ORDER MODIFYING AND APPROVING REVISED EROSION MONITORING PLAN

Erosion Monitoring Plan

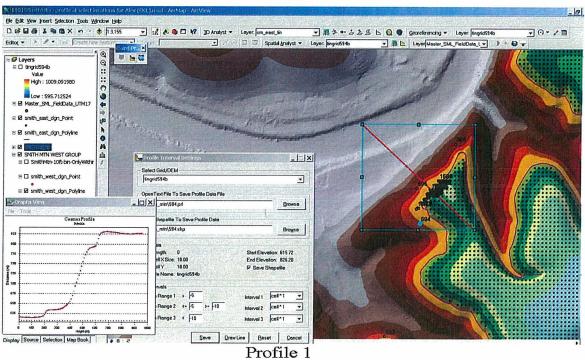
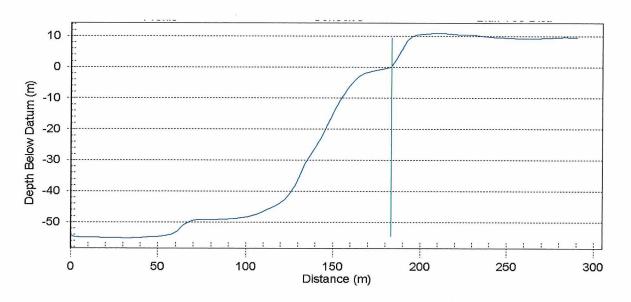
Figure 18: Detailed Location and Profile of Site S1, Smith Mountain Lake

Existing Profile (Bluff Toe Dist 183m)

These sites represent areas of varying conditions. Maps showing these locations and photographs of the previously monitored sites from the 2007 study report are located in Appendix A. Also in Appendix A are the original profiles that were generating at Sites S1, S3, S4 and L1 and the Wind-Wave Height mapping for Smith Mountain and Leesville.

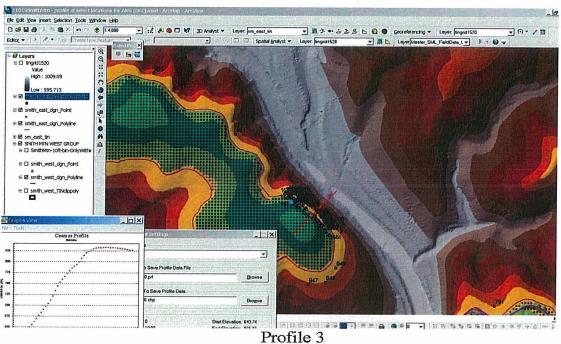
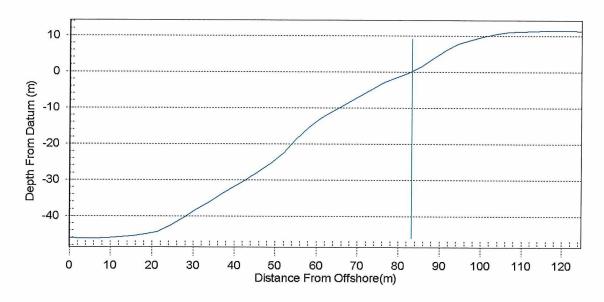
Figure 19: Detailed Location and Profile of Site S3, Smith Mountain Lake

Existing Profile (Bluff Toe Dist 83.25m)

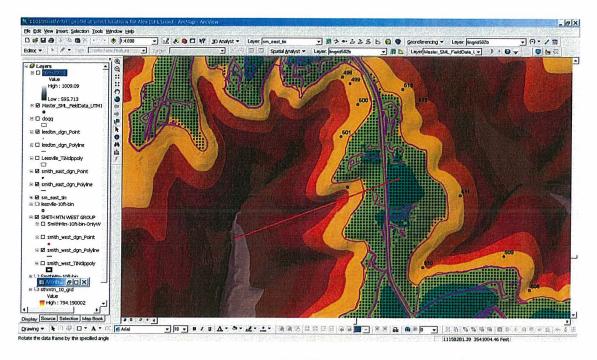
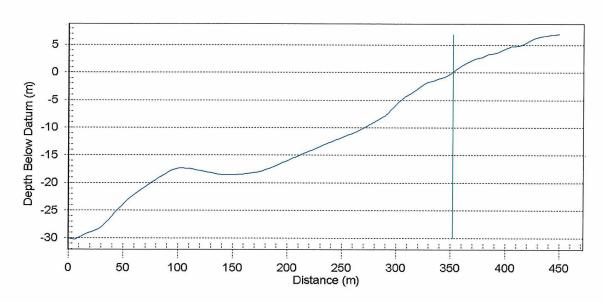
Figure 20: Detailed Location and Profile of Site S4, Smith Mountain Lake

Profile 4
Existing Profile (Bluff Toe Dist 352m)

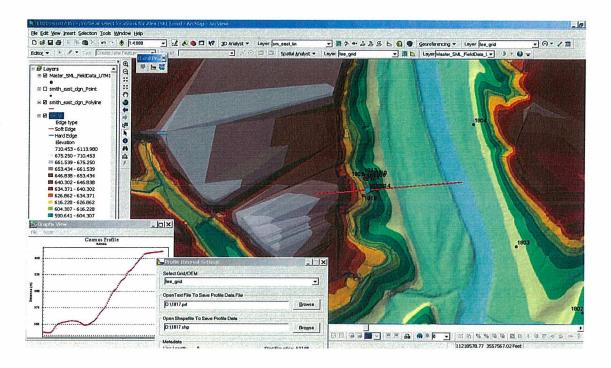
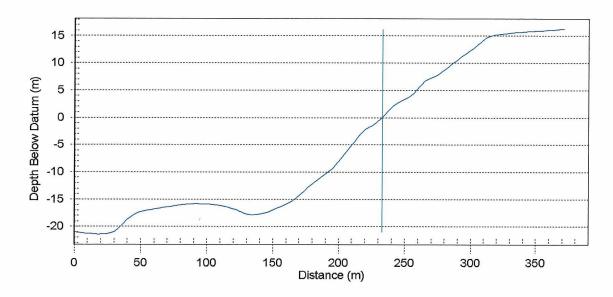
Figure 21: Detailed Location and Profile of Site L1, Leesville Lake

Profile 5
Existing Profile (Bluff Toe Dis 233m)

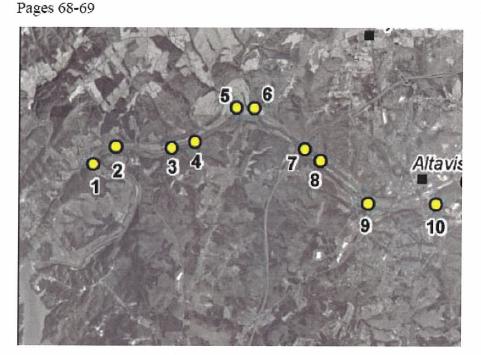
Appendix B: Downstream Monitoring Locations

Survey Point	Distance Downstream (Miles)	Description
,	3.45	Confluence with Goose Creek. Channel 90 feet wide; 3-5 ft deep. Sand deposition in Goose Creek backwater zone. Gravel bar downstream from bridge. Islands downstream. Sandy, steep banks 20 feet high both sides. Evidence of active erosion on bottom 2 feet. Exposed tree roots. Photos 2242-2245.

3.97	Channel 120-150 feet wide; 3 feet deep. Otherwise as point 1. Photos 2246-2247.
3	4.92	As point 2. Photos 2248-2249.
4	5.31	80 feet wide. Bed not visible, beyond probe depth – over 6 feet deep. Large woody debris protecting banks. Banks 20 ft high, steep, sandy, erosion over bottom 1-2 ft. Photos 2250-2251.
5	6.24	100 feet wide and 3 feet deep. Riffle downstream. Low sinuosity; moderate velocity and sediment load. Large woody debris. Overgrazed section – bank erosion by poaching (action of cattle) on both banks. Banks steep, sandy, sparse vegetation. Photo 2252.
6		Same as point 4. Photo 2253.
7		Same as point 6. Photos 2254-2255.
8	9.14	Pipe crossing - pipe exposed. Photo 2256.
S	10.21	Channel 150 feet wide and 3 ft deep. Moderate bedrock outcrops, Banks as before – erosion line 12-18 inches. Upstream from Alta vista. Photos 2257-2258.
10	11.38	70 feet wide and 1 ft deep. Riffle downstream from Alta Vista boat ramp. Sandy banks actively eroding on bend next to riffle – 20 feet high – slumping and block failure. Photo 2193.

Downstream: Ten sites between Leesville Dam and Altavista as shown on the map in Appendix B will be monitored to document bank conditions. These are the same ten sites that were monitored in the Erosion Study completed as part of the relicensing efforts.

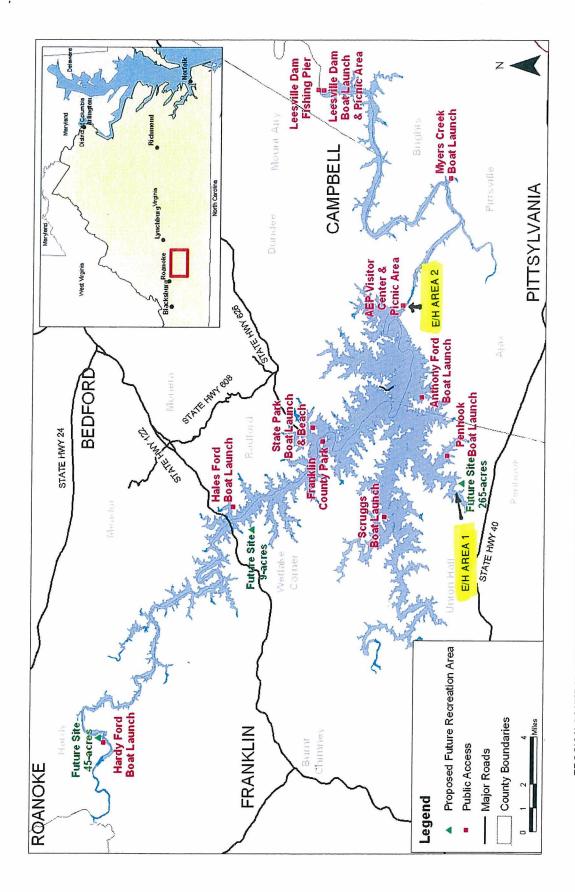
Appendix C: Map of Demonstration Project Areas

EROSION CONTROL / HABITAT DEMONSTRATION PROJECTS - AREAS 1 & 2

Appalachian will be developing two demonstration projects utilizing natural methods for stabilizing eroding shoreline (one project on Leesville and one project on Smith Mountain.) These projects will be coordinated with the Virginia Department of Game and Inland Fisheries (VDGIF) under Appalachian's Habitat Management Plan (HMP). The intent is to utilize natural methods that provide erosion protection and also enhances the shoreline habitat. These sites will be monitored under the HMP to assess the effectiveness of natural methods. Once effective methods are established, they will be considered for other areas as part of the HMP. Details of effective methods will also be shared with others within the lake community.
